MEMORANDUM REPORT ARBRL-MR-03284

SURVIVABILITY TESTS ON A NUCLEAR WASTE  
CASK IN SIMULATED RAILROAD  
ACCIDENT FIRES

June 1983

US ARMY ARMAMENT RESEARCH AND DEVELOPMENT COMMAND  
BALLISTIC RESEARCH LABORATORY  
ABERDEEN PROVING GROUND, MARYLAND

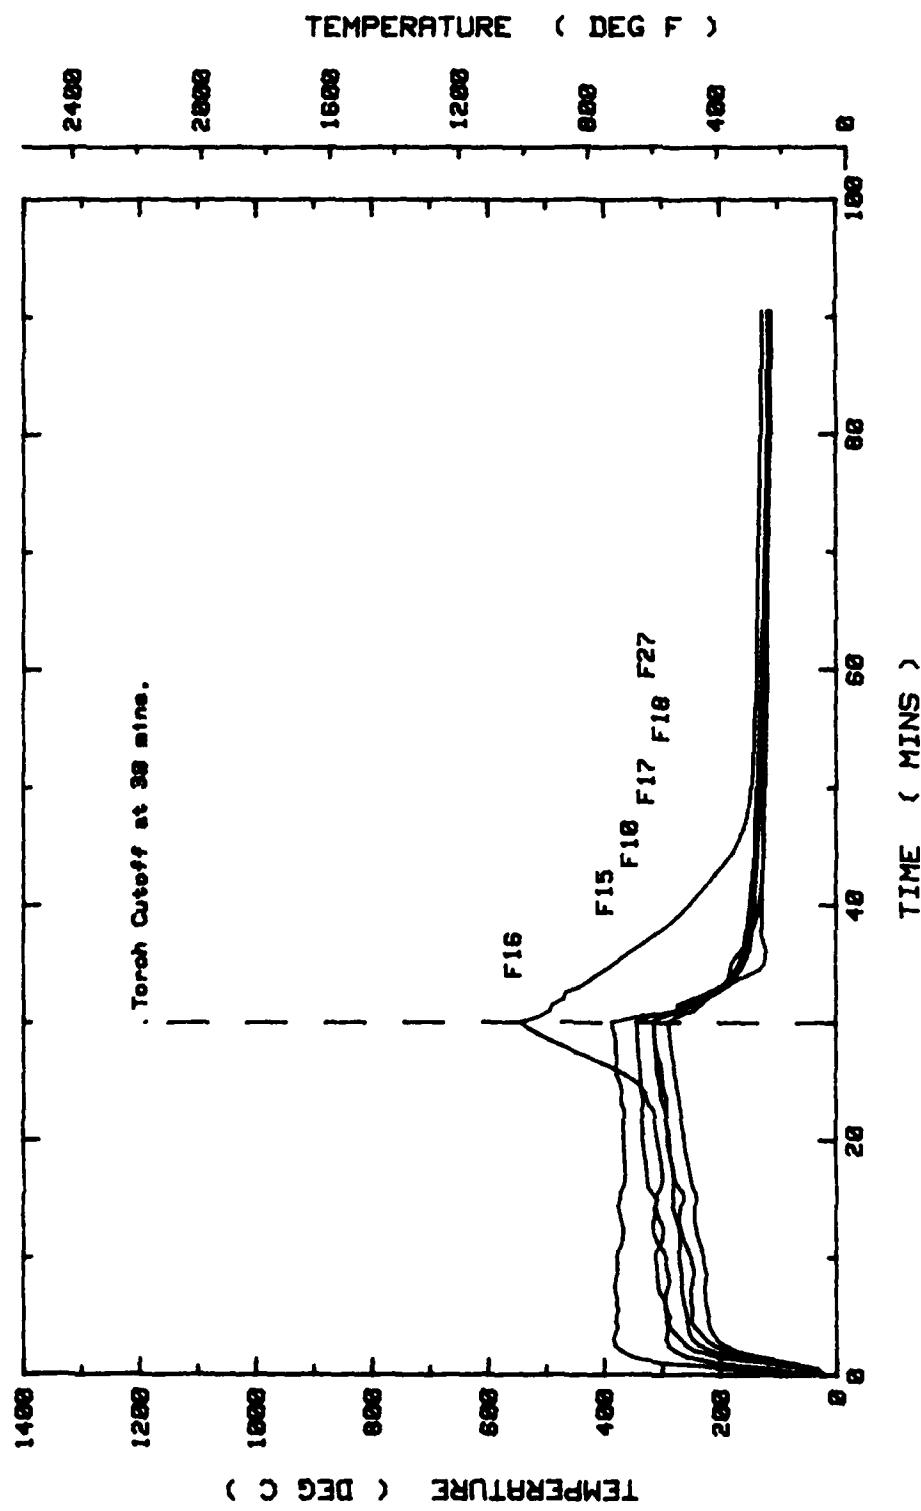
Figure 18: Temperature as Functions of Time for TCs Distributed Angularly at the Axial Position of 289.6 cm on the Outer Surface of the NSJ for HNPF Cask Test Number 1

The TC F16 apparently malfunctioned, so its measurements are assumed to be faulty. Even though the TCs F15 and F17 are at equal angular distances above and below the TIC position, the peak temperature of F15 was  $80^{\circ}$  C higher than the peak temperature measured by F17. Since F15 was the upper TC and F17 was the lower one, the torch flame apparently deposited more heat toward the upper side of the cask. F18 was positioned below F17 and recorded an even lower valued peak temperature. The TC F27 was positioned at  $325^{\circ}$ , which is a position on the opposite side of the cask and  $35^{\circ}$  from the ARP, but its peak temperature measurement was nearly the same value as that measured by F17. This was the case in spite of the fact F27 was much further away from the TIC. This also supports the observation mentioned previously that the torch flame has a tendency to deposit more heat toward the top side of the cask.

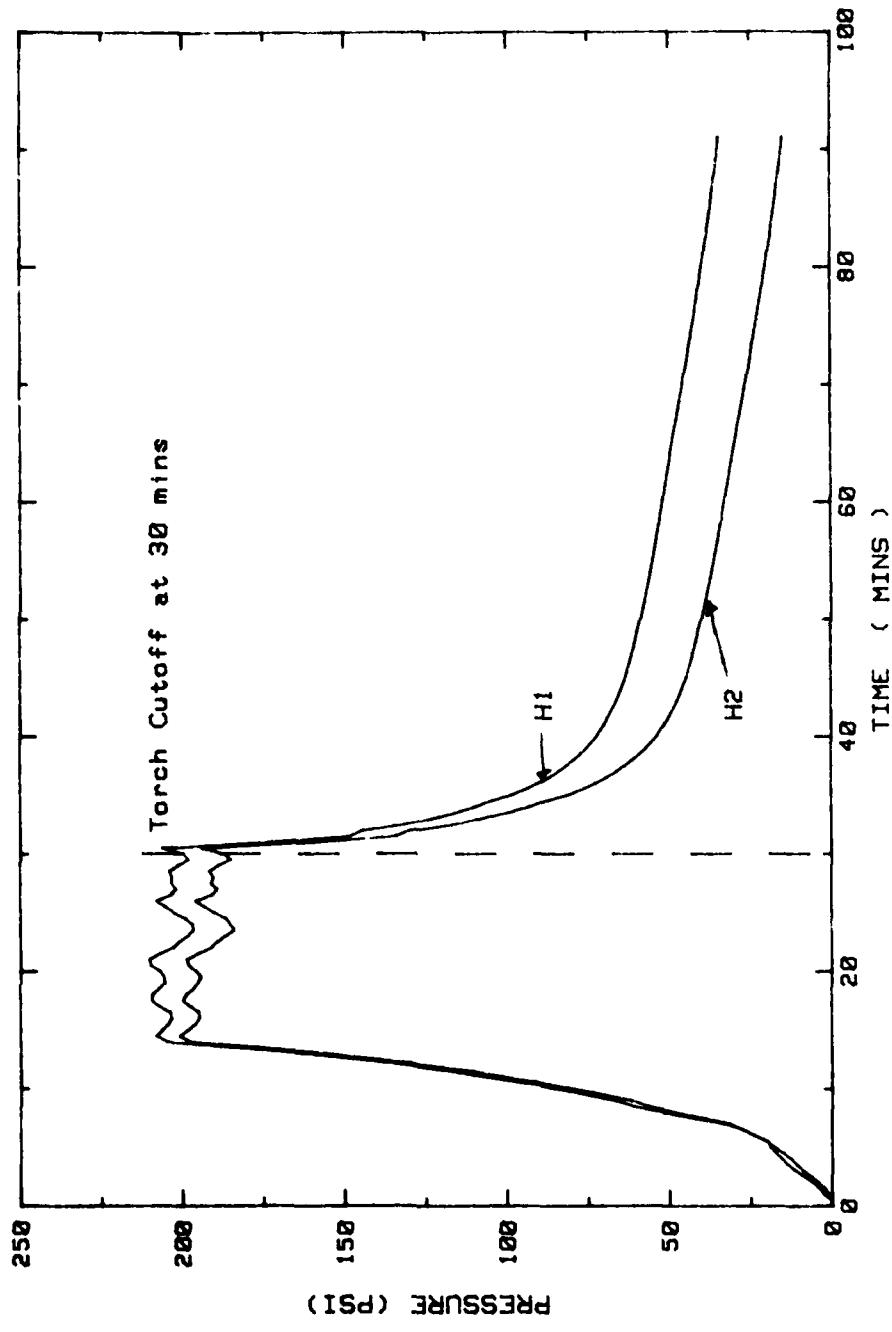
The pressure level values are presented in Figure 26. The peak value measured by these gauges is approximately 210 psi which corresponded to the setting of the pressure relief valves. The water was vented through the relief valve when the pressure exceeded 210 psi as indicated by the fluctuations. The pressure did not decline permanently until the torch was extinguished, a fact which further indicates that the cask seals were not damaged.

Figure 26: Pressure as Functions of Time Inside the NSJ for HNPF Cask Test Number 1

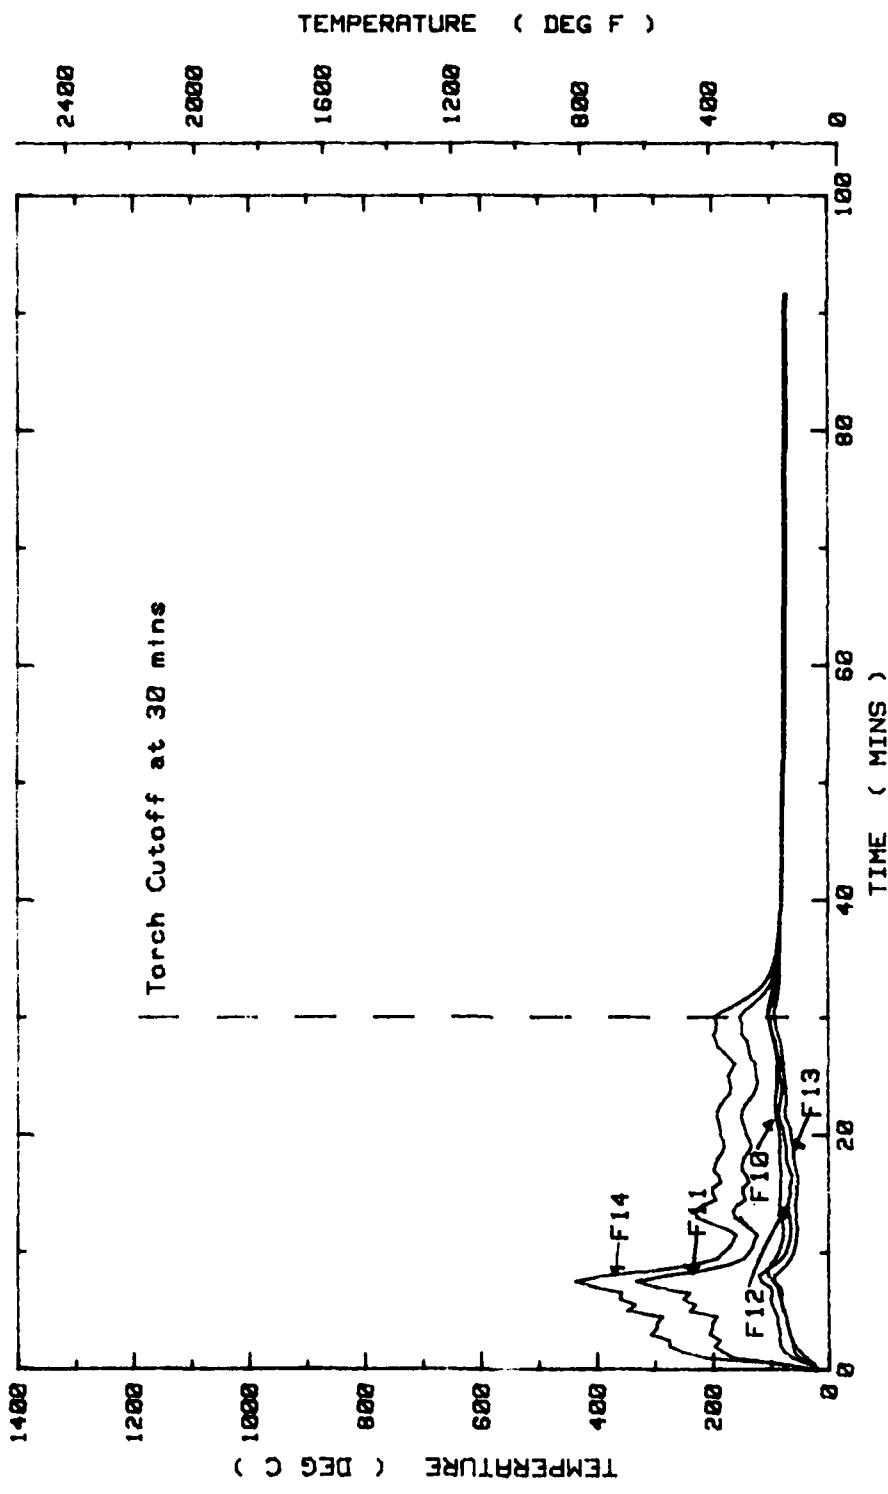
Figure 35: Temperature as Functions of Time for TCs Centered About the Position 289.6 cm from the XRP and Located on the Outer Surface of the NSJ for HNPF Cask Test Number 2

The temperature profiles for the TCs which were distributed about the point on the cask with the position of 90° angular coordinate and an axial coordinate of 289.6 cm are presented in Figure 35. The TCs of this group which were positioned closest to the TIC were F14 and F11. Both of these rose to a sharp peak (410° C and 325° C, respectively) and then fell to approximately 200° C and maintained a steady value. The remaining TCs of the group stayed in the neighborhood of 75° C with their measurements. The temperature profiles shown in Figure 36, where all of the TCs which measured those values were positioned at 289.6 cm (114 inches) from the XRP, are all similar with the peak value reaching approximately 80° C. The temperature of the flame was 1100° again so that the effect of moving the TIC was to increase the temperatures about the TIC by approximately 100° C as far as the surface of the NSJ was concerned.

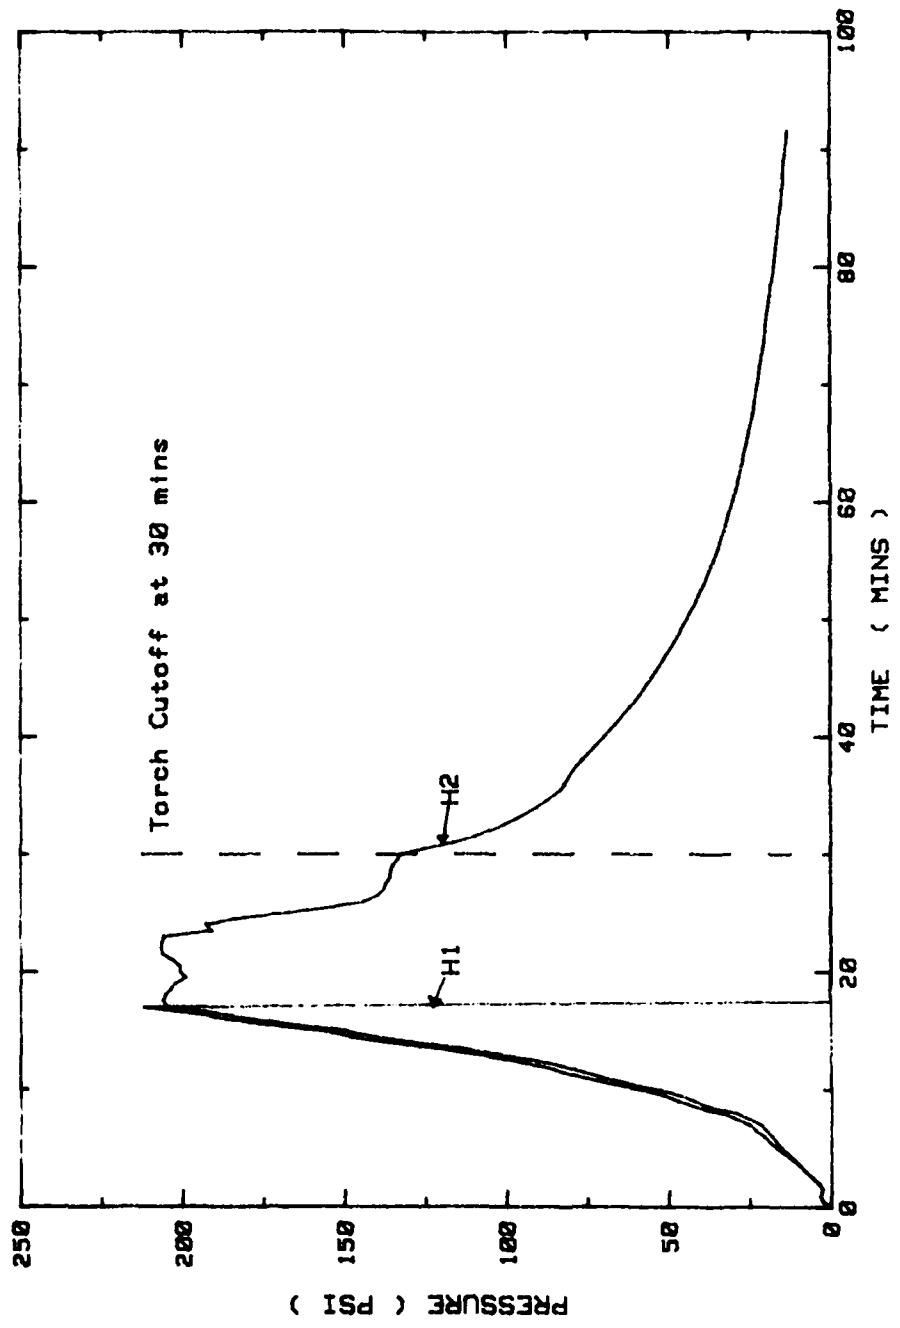
The pressure level values are presented in Figure 41 for Test Number 2. It appears that the H1 pressure gauge failed at approximately 18 minutes. The other pressure gauge reached 210 psi and maintained that value for about eight minutes, but then the pressure began to fall rapidly which could be because of a leak in the seals. However, the next two tests were conducted without water in the NSJ so that was not confirmed.

Figure 41: Pressure as Functions of Time Inside the NSJ for HNPF Cask Test Number 2

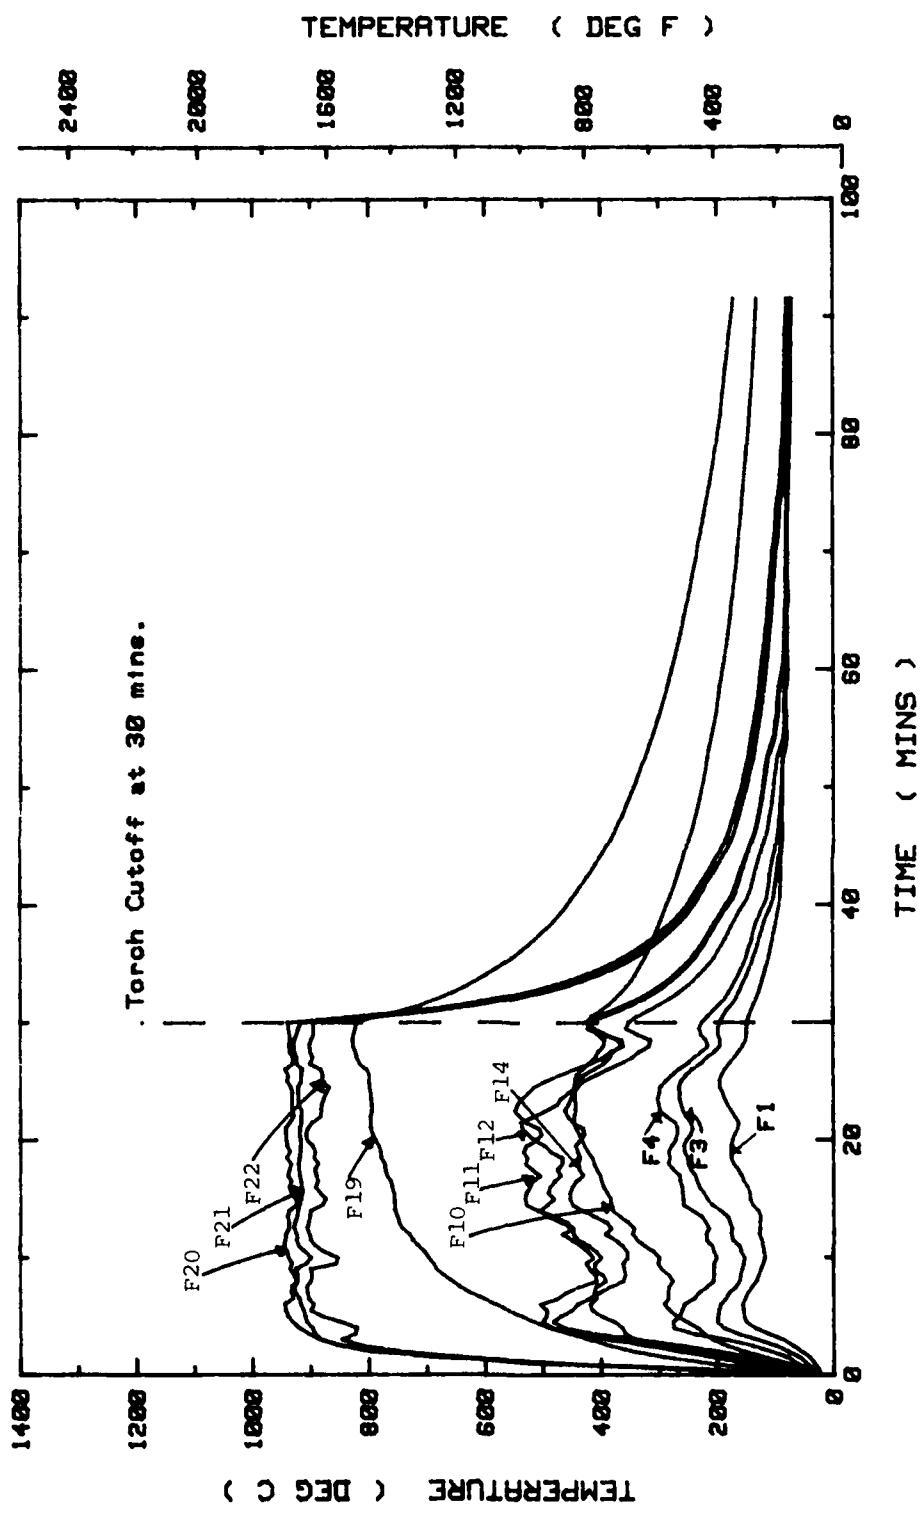
Figure 49: Temperature as Functions of Time for TCs Centered About the Position 289.6 cm from the XRP and Located on the Outer Surface of the NSJ for HNPF Cask Test Number 3

While there was some spread in their measurements, the average temperature achieved was in the neighborhood of 450 °C, nearly half that value of the other TCs. The TCs which measured the lowest temperatures were F1, F3, and F4. The reason for this was due to the distance from the TIC (centered about 165 cm from the XRP) and the fact that these TCs were also on the opposite side of the cask from the TIC. Figure 50 presents the temperature profiles for the TCs which were distributed angularly at the axial position of 289.6 cm, the same axial position of the TIC. The TCs F19, F24, F25, F26, and F27 were located on the same side as the TIC. All of these measured temperatures such that the temperature profiles are similar in shape and magnitude except for F27 which apparently made erroneous measurements. It is strange that the general shape of these temperature profiles is so much different from those presented in Figure 49. Also, these TCs measured about 100 °C less at the peak values. The remaining TCs in Figure 50 were positioned on the opposite side of the cask from the TIC. The TC closest to the TIC measured the highest temperature (500 °C) and was designated F16. F18 was the TC located the farthest away from the TIC, and it measured the lowest peak temperature (175 °C). The effect of not having water in the NSJ is apparent by the values of these data.

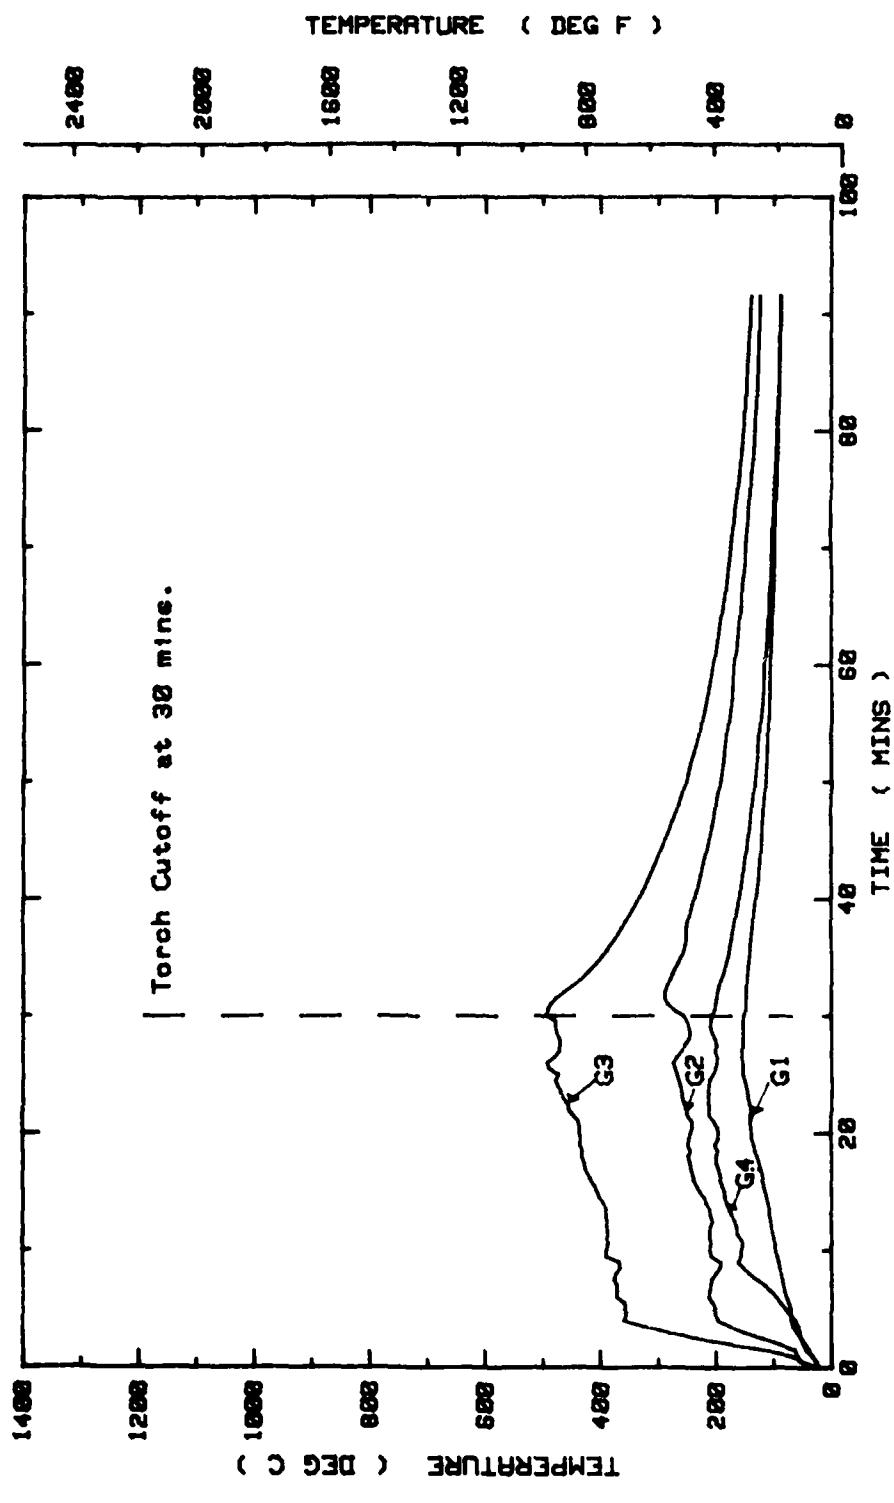
The temperature data presented in Figure 51 were measured by the TCs located inside the NSJ which would be measuring the temperature of the water if water had been present. Without the water, G3, which was located at the same position as the TIC, reached a temperature level of nearly 500 °C. The other TCs (G2, G4, and G1) measured lower temperatures in direct proportion to their distance from the TIC. In the previously discussed test data, these TCs increased gradually and at the same rate because of the water in the NSJ. That was not the case without the water.

Figure 51: Temperature as Functions of Time for TCs Positioned Inside the NSJ for HNPF Cask Test Number 3

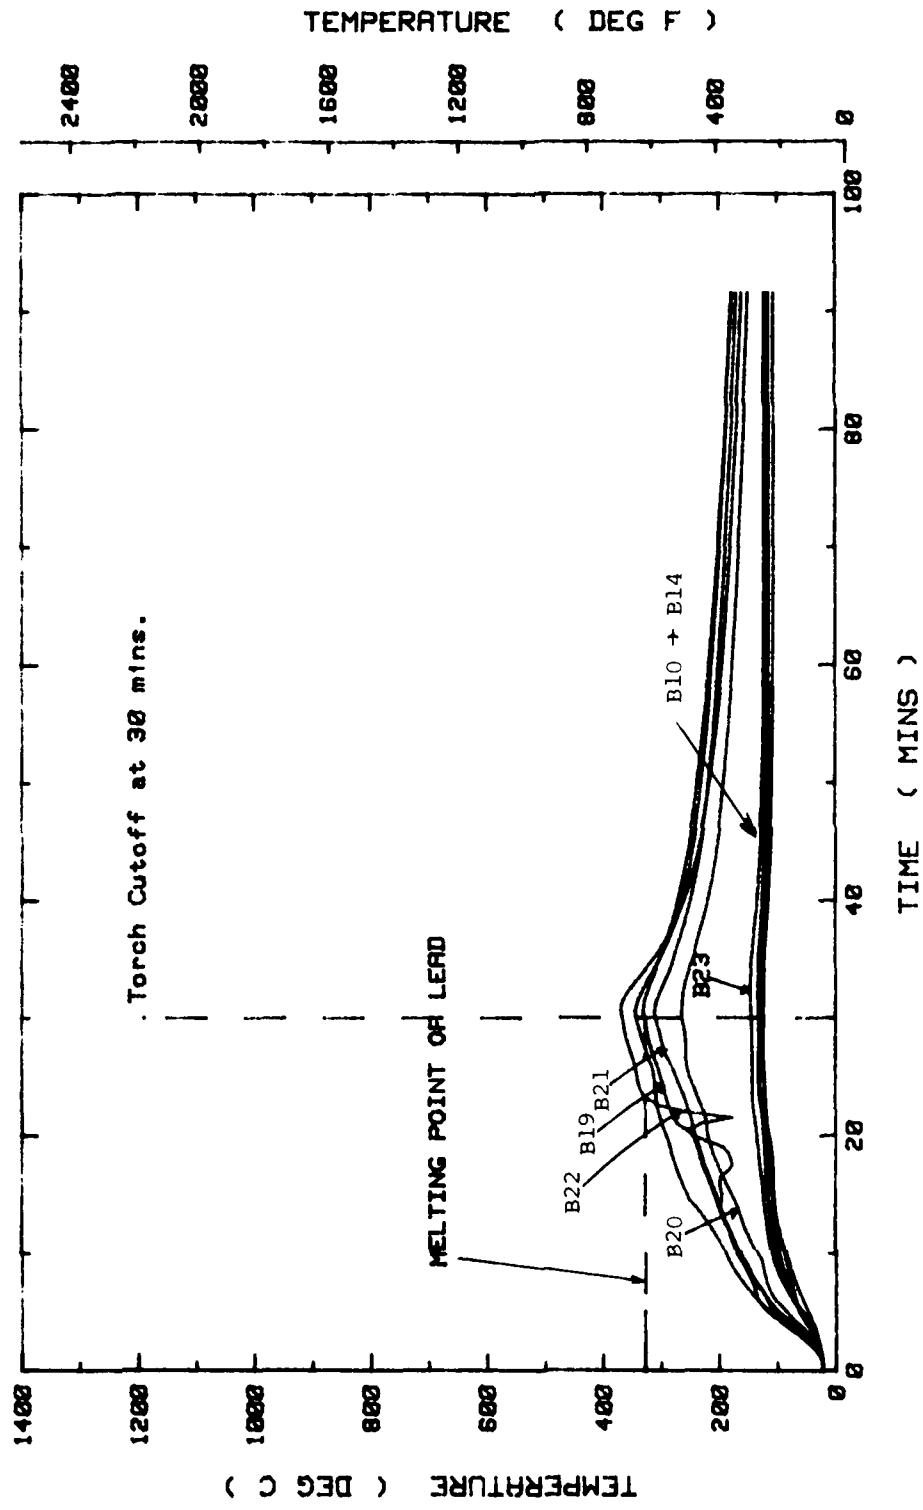
The temperature as functions of time for the TCs positioned on the outer surface of the OSS is presented in Figures 52 and 53. The TCs which measured the data in Figure 52 were distributed axially around the axial position 289.6 cm. The TCs B19, B20, B21, B22, and B23 were located at 270°, on the same side as the TIC. As the figure shows, at least one of the TCs measured temperatures above 320 °C which is the melting point of lead. The remaining TCs were positioned on the other side of the cask and measured temperatures not exceeding 110 °C. Figure 53 presents the TCs which were distributed angularly at 289.6 cm. One of these TCs almost measured temperatures above 320 °C. An additional factor is that the slope of the temperature curves, when the torch was extinguished, was positive so that if the torch had remained on, even higher temperatures would have been achieved. The significance of these high values is that the OSS is adjacent to the lead shield, so that there is a chance the lead shield partially melted. If so, it could have expanded sufficiently to damage the ISS or the OSS. In order to verify any suggestions about this, the cask will have to be disassembled and the components examined.

Figure 52: Temperature as Functions of Time for TCs Centered About the Position 289.6 cm from the XRP and Located on the Outer Surface of the OSS for HNPF Cask Test Number 3

- (1) The HNPF Cask should be disassembled and the internal parts examined.
- (2) Since the water in the NSJ prevented undue temperature buildup in Test Number 5, future pool fire simulation tests should be conducted without the water.
- (3) In an accident, the NSJ has a good chance of being ruptured which would allow the water to drain out leaving the cask vulnerable to fires. Therefore, an alternative should be considered such as polyethylene. This material has similar neutron shielding properties but would not drain out of a ruptured jacket until it had become melted by the fire.

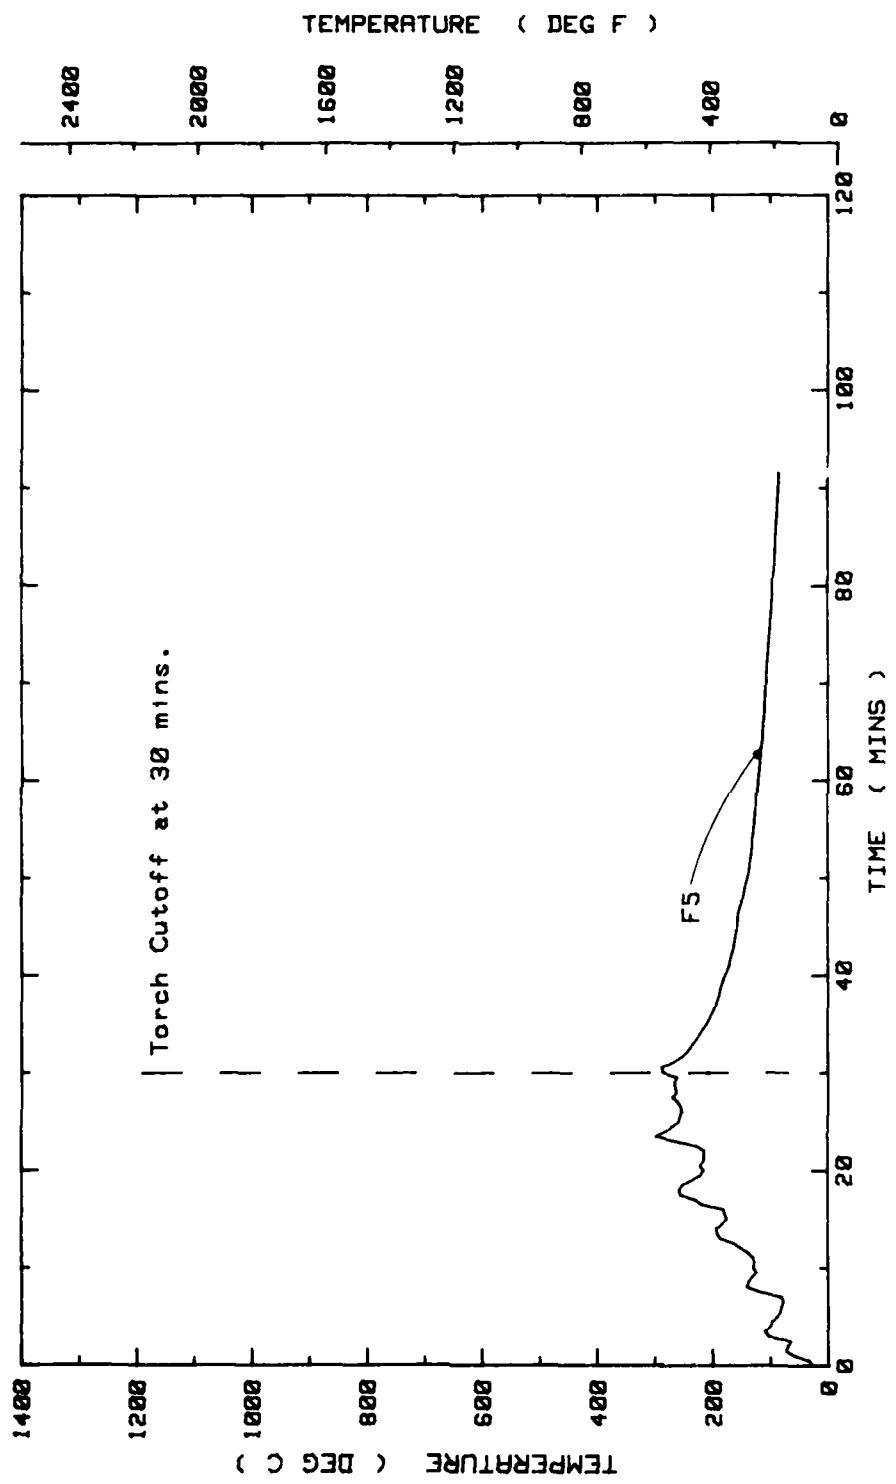
The temperature as a function of time for one TC located on the outer surface of the NSJ and 33.0 cm (13 inches) from the XRP is presented in Figure 69. The temperature there reached approximately 250 °C (482 °F), which indicates that the flame did not reach much beyond the impact limiter. The remaining data for TCs located on surfaces which were deeper inside the cask are presented in Figures 70, 71, and 72. The temperature levels measured by all of these TCs were much too low to be considered as a serious threat to the survivability of the cask. Consequently, even though the NSJ was void of water, an end-on torch impingement was shown to be inconsequential.

Figure 69: Temperature as a Function of Time for the TC Located at 33.0 cm from the XRP on the Outer Surface of the NSJ for HNPF Cask Test Number 4

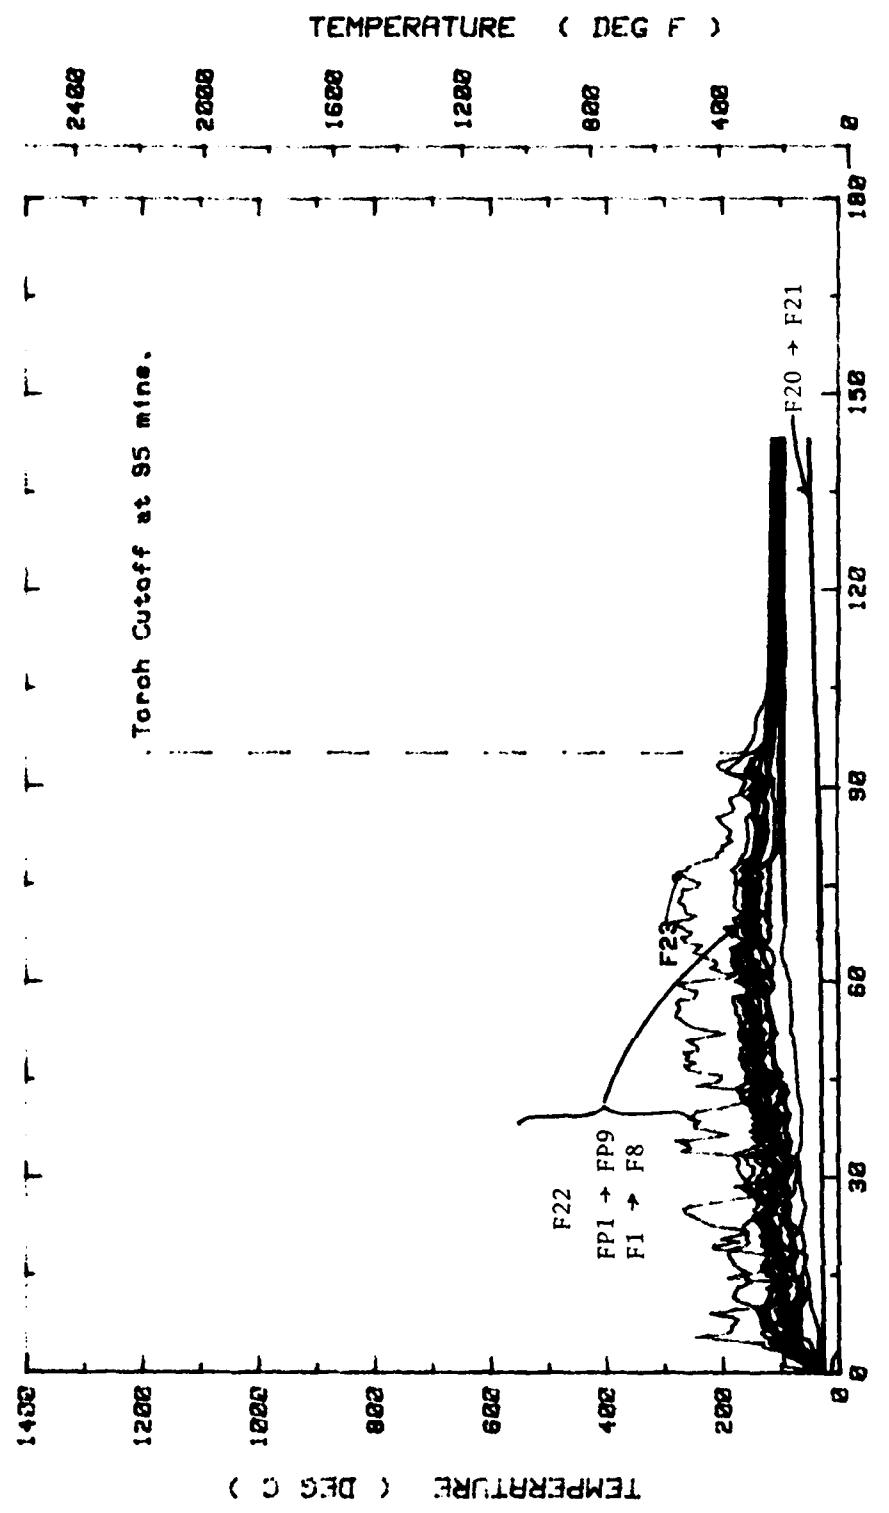
As Figure 79 indicates, the temperatures measured by the TCs on the outer surface of the NSJ for Test Number 5 did not exceed 150 °C (302 °F). Therefore, this test was not a severe test for the HNPF Cask. As would be expected, the temperatures measured by TCs positioned on the other surfaces interior to the cask were even lower. The highest temperature measured by the TCs on the outer surface of the OSS did not exceed 100 °C (212 °F), and the temperatures measured by the TCs positioned on the inner surface of the ISS were even lower. These observations were made from the data presented in Figures 80 and 81.

Figure 79: Temperature as Functions of Time for TCs Positioned on the Outer Surface of the NSJ for the HNPF Cask Test Number 5

- (4) The pool fire simulation condition is not a threat to the HNPF Cask as indicated by Test Number 5 provided the NSJ is filled with water.
